United States Steel Corporation

# Resolution Manual For Metal Building Construction

## Job Site Imperfections

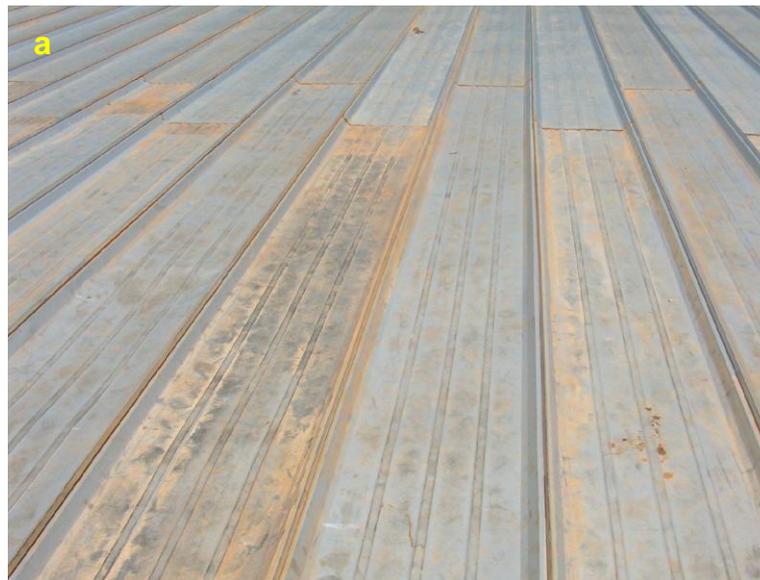
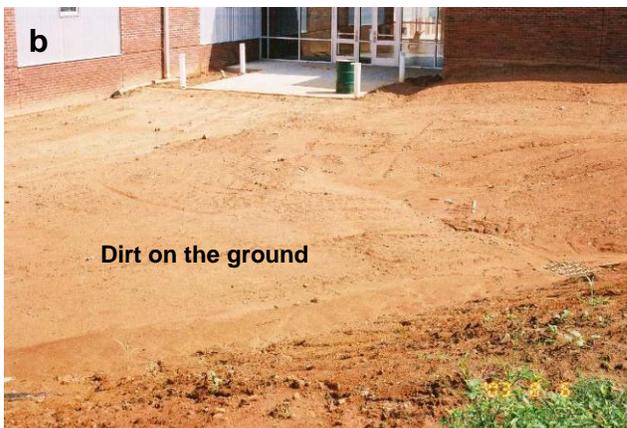
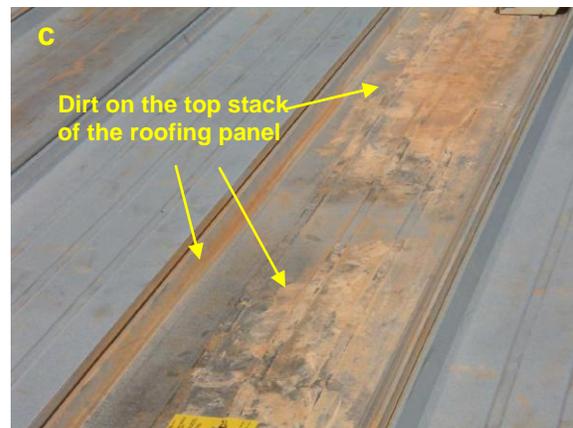
Staining and an inconsistent appearance of bare GALVALUME<sup>®1</sup> Coated Sheet Steel roofs can be caused by dirt being introduced by either foot traffic and/or poor storage practices. The example in Figure 1 showed that the dirt on the roof (Figure 1a) matched the dirt on the ground (Figures 1b). The dirt was concentrated on the roofing panels on the top of the stack (Figure 1c) and transferred to the other panels by construction workers walking on the roof. If the dirt is not cleaned immediately after installation, it will cause staining and an inconsistent appearance to the roof, and possibly cause premature corrosion by trapping the moisture on the roof. Therefore, dirt and other debris should be cleaned immediately after installation.

Figure 1. Photographs of stains and inconsistent appearance of a bare GALVALUME<sup>®</sup> roof (a), dirt on the ground at a building site (b), and dirt concentrated on the roofing panels on the top of the stack (c).

The best way to avoid staining of panels is to maintain proper storage and handling practices during the entire construction process to avoid dirt getting on the panels in the first place. Annual washing of the building is recommended to maintain the overall appearance of the building. The useful life of the roof will also be extended by removing dirt and other moisture trapping debris, which can cause premature corrosion.

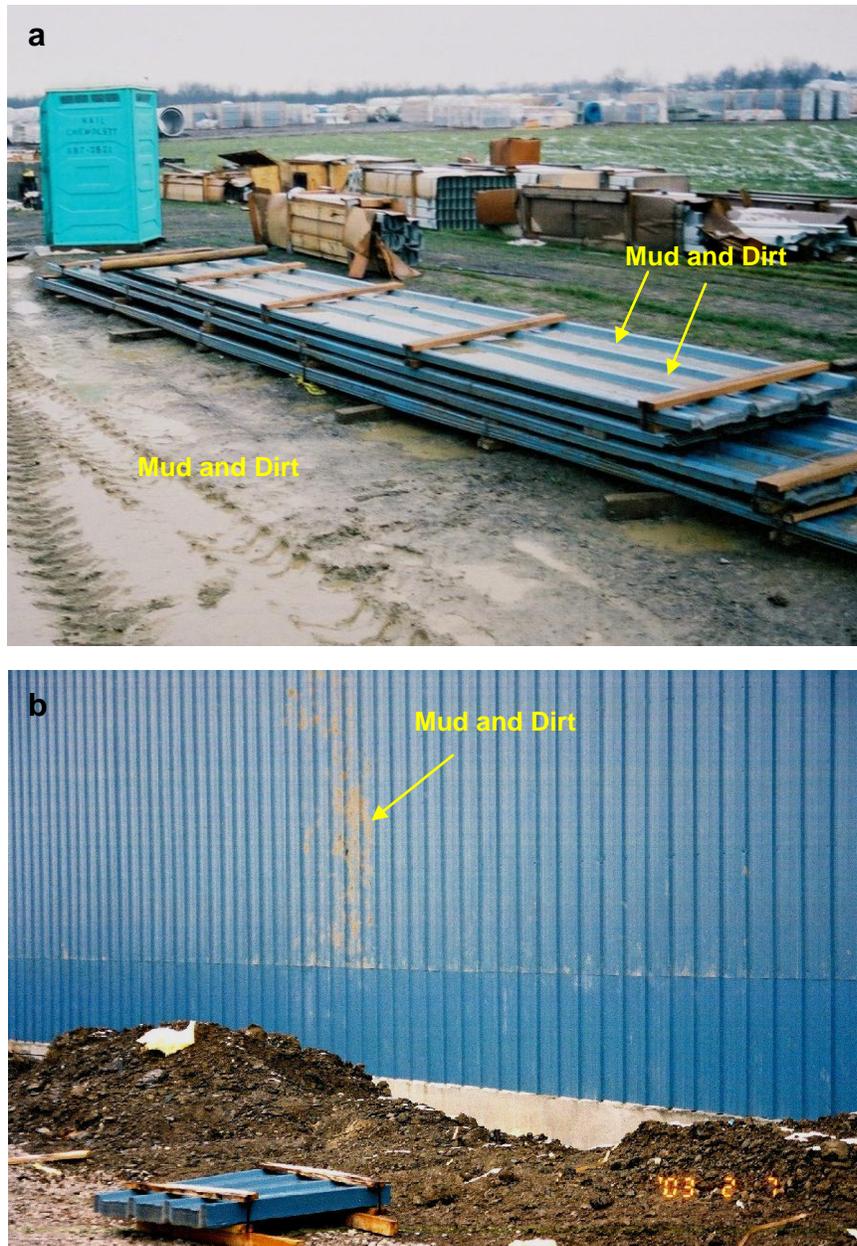
Similar dirt issues can also occur on prepainted panels. Figure 2 shows dirt and mud on the job site was transferred onto the surface of the prepainted GALVALUME<sup>®</sup> sidings before installation (Figure 2a), and the mud remained on the panels after installation causing appearance issues (Figure 2b). Dirt also concentrated on the top panel of the stack. The best way to avoid this situation is to maintain proper storage and handling practices during the entire construction process to avoid the dirt and mud getting on the panels in the first place. Dirt and mud should be cleaned immediately after installation.

Figure 2. Photographs of mud and dirt on the prepainted GALVALUME<sup>®</sup> siding panels (a) before and (b) after the installation.

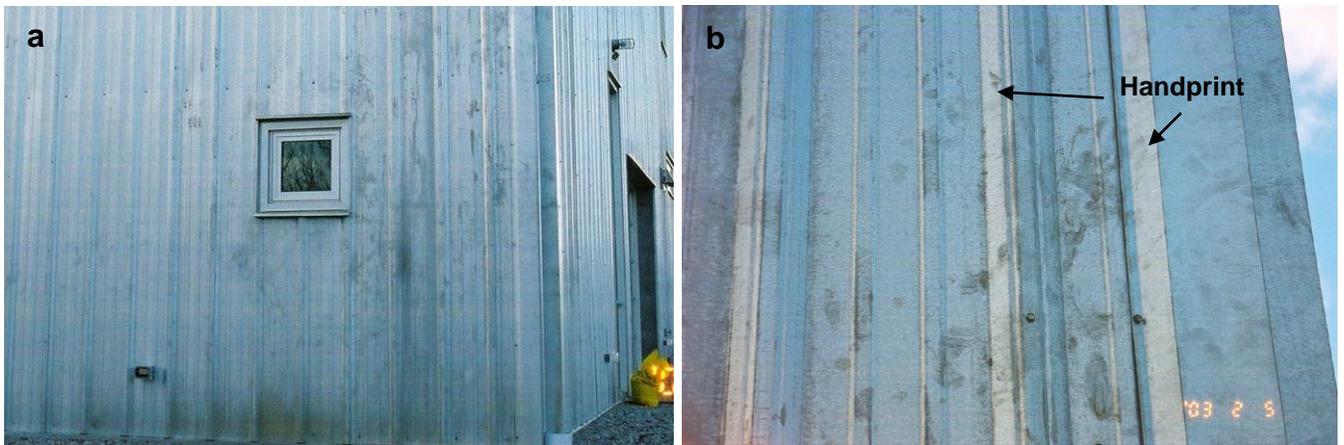
Hand and palm prints on bare galvanized and GALVALUME® panels are the likely result of not using clean gloves in handling the panels during installation. Dirt, oil and perspiration have been shown to be detrimental to the appearance of bare coated products, such as galvanized and GALVALUME® Coated Sheet Steels. Figure 3 demonstrates the results of poor handling practice during the installation of bare GALVALUME® siding, which left handprints on the siding. Figure 4 shows the non-uniform darkening smudge marks due to excessive abrading of the surface of the roofing panels and footprints on the GALVALUME® roofing panels. Panel-to-panel contact, walking on the panels, and not using clean gloves can also cause poor appearance. The contractor should be cautioned, prior to installation, to avoid poor handling practices, since the contractor is ultimately responsible for these imperfections. However, it should be noted that the darkening or smudging does not affect the corrosion performance of the panels.

Figure 3. Photographs of handprints and smudge marks on bare GALVALUME® siding (a), and close-up view (b).

Instead of bare GALVALUME® Coated Sheet Steel, ACRYLUME®<sup>2</sup> Coated Sheet Steel can be used, which provides better hand, footprint and smudge mark resistance. ACRYLUME® Coated Sheet Steel has a very thin clear acrylic coating over GALVALUME® Coated Sheet Steel. The acrylic coating also provides better protection during storage.

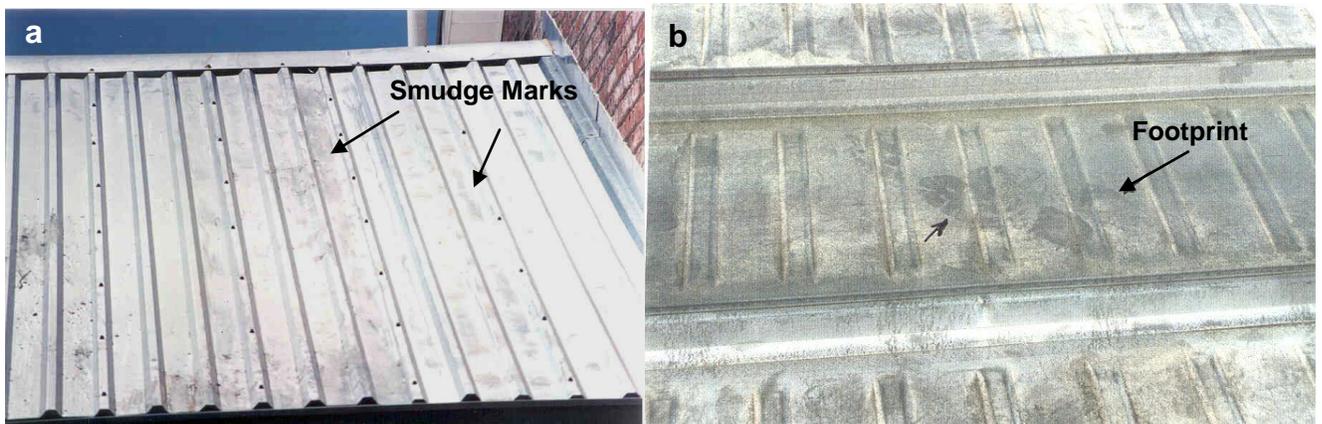
Figure 4. Photographs of smudge marks (a) and footprints (b) on bare GALVALUME® roofs.

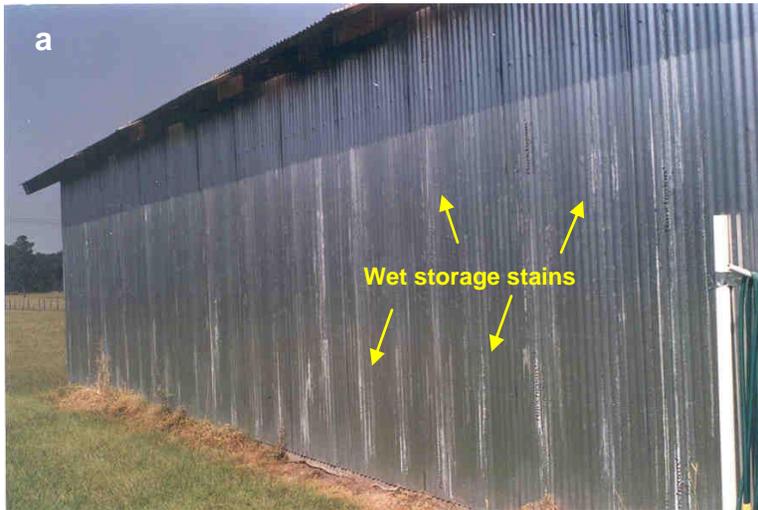
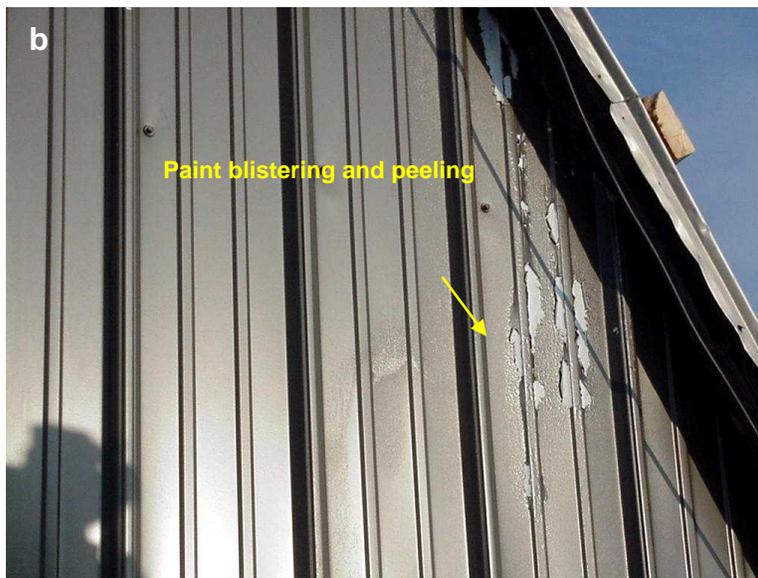
Figure 5a shows white rust and storage stain, on the bare galvanized steel. Wet storage problems are not limited to bare materials. Prepainted products are also susceptible to wet storage issues, which occur when the panels are in bundle form and exposed to moisture, such as the siding panels shown in Figure 5b. The difference with painted panels is that the corrosion starts underneath the painted surface and first appears in the form of blisters or a rough surface, which eventually progress to the point at which the paint peels from the galvanized steel panels. For more information, see National Coil Coater's Association Technical Bulletins at <http://www.coilcoating.org>.

Wet storage stain can be easily identified. Typically, there is no orientation to the staining pattern, but the white rust or the stain patterns should be on both sides of the panel. If the panels are still stacked in the bundle, the pattern should be in a mirror image on the bottom side of the panel to the top side of another panel that it was in contact with.

Figure 5. Photographs of wet storage stains on bare galvanized steel siding (a), and wet storage causing paint blistering and peeling on prepainted galvanized steel siding (b).

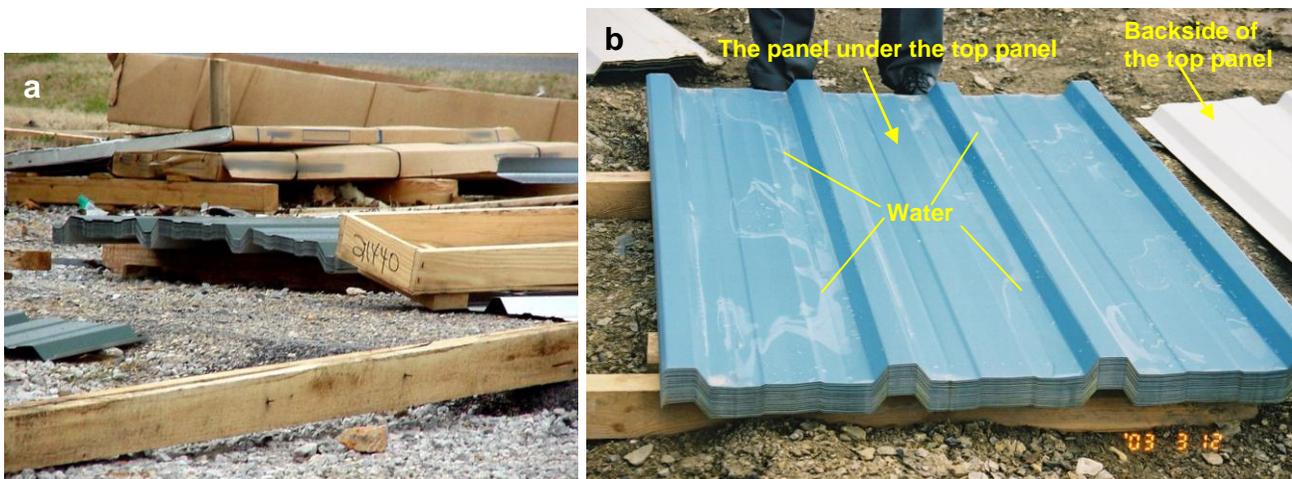
Wet storage conditions are frequently found on job sites where panel bundles are improperly stacked (Figure 6a), or are laid flat on the ground, without protection (Figure 6b). Water can penetrate between the panels by condensation, or capillary action, creating wet storage conditions, which cause paint blistering and substrate corrosion on the prepainted panels, while causing storage stain on the bare hot dip galvanized or GALVALUME® Coated Sheet Steel. Therefore, panels and accessories should not be stored in wet conditions. Care should also be taken to avoid handling damage on the job site. The panel storage condition shown in Figure 6a could potentially create a wet storage condition and cause premature corrosion. It could also cause damage to the panel before installation.

Figure 6. Photographs of panel bundles improperly stacked at the job site (a), and water on the surface of a panel that was in the bundle under the top panel (b).

Bundles should be positioned with one end slightly elevated to permit runoff of moisture from the top of the bundle or from between nested panels. Water-resistant paper will not necessarily provide long-term resistance to moisture penetration from puddled water on top of the bundle. A waterproof cover should be placed over the bundles while allowing for air circulation under the cover (see Figure 7). More information can be found in U. S. Steel Technical Bulletins at <http://www.ussteel.com> or in the National Coil Coater's Association Technical Bulletins at <http://www.coilcoating.org>.

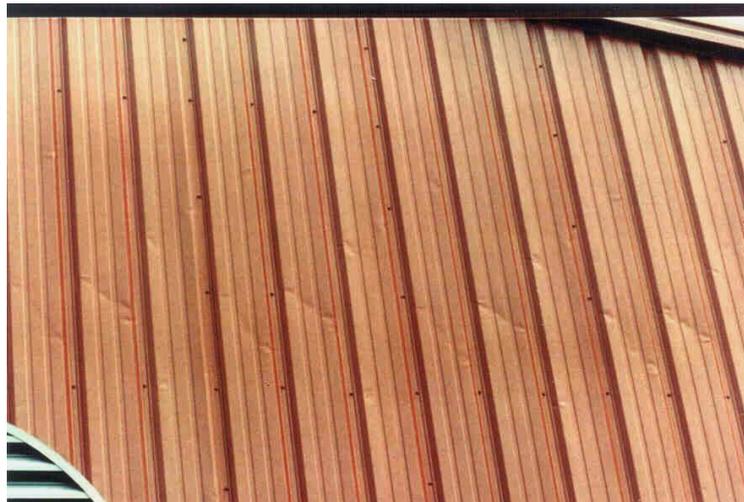
Figure 8 is an example of transit and handling damage. The pattern of the damage is typical of handling issues while panels are still in bundle form. Regardless of whether the damage was caused by blocking, forklifting or by some other external force, it usually exhibits a repetitive pattern. Nevertheless, the damaged panels should have never been installed. Figure 9 shows other examples. Mishandling of the panels caused paint abrasion damage at the radii of the major ribs in the up-down direction (Figure 9a), which could result in premature corrosion. The scratches on the surface of painted panel caused premature corrosion in the damaged area (Figure 9b).

Figure 8. Photograph of damaged panels on the building's sidewall.

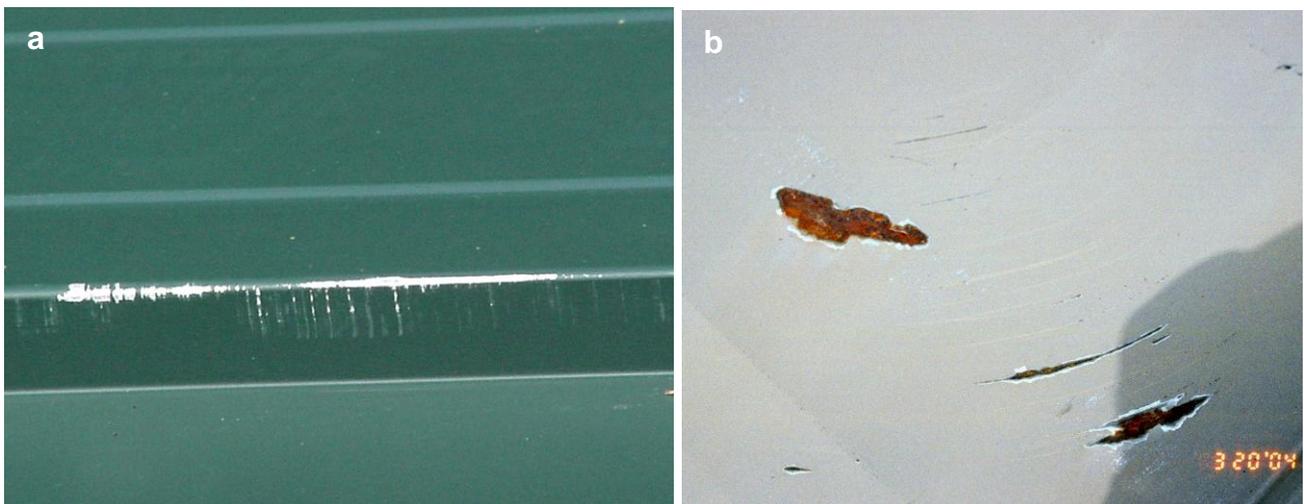
Figure 9. Photographs of paint abrasion damage on the major rib of the panel (a), and scratches on the surface of a painted panel resulted in premature corrosion (b).

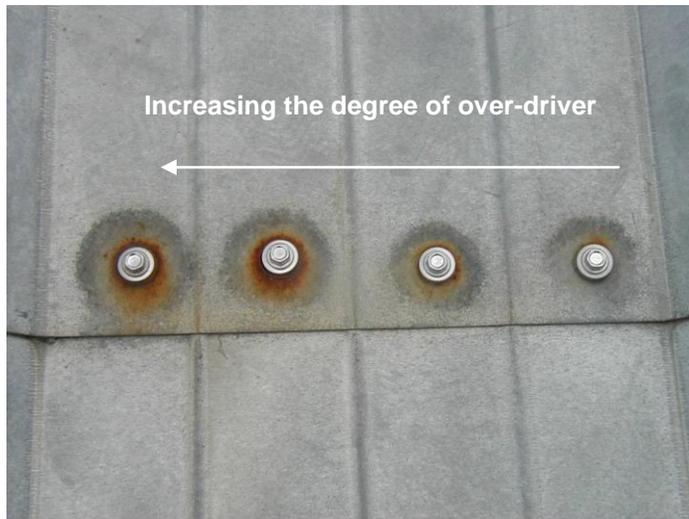
Figure 11. Photograph of the over-driven fasteners. The corroded area around the fastener increased with increasing depth of depression.

Fasteners should be installed properly to avoid being over-driven, under-driven or driven at an angle. Figure 10<sup>3</sup> is a schematic example of the proper and improper installation of fasteners. Properly seated and installed fasteners should be watertight and not allow water to leak or allow water to collect around them. Over-driven fasteners may cause depressions around the fasteners, which can collect water and accelerate corrosion. Therefore, impact-type tools should not be used. Figure 11 is an example of over-driven fasteners. The GALVALUME® material around the fasteners was corroded due to water ponding in the depression. The corroded area around the fastener increased with increasing the depth of the depression. Under-driven fasteners or fasteners that “back out” over time can allow water to leak at fasteners allowing water to saturate insulation causing inside-out corrosion (Figure 12<sup>4</sup>). Driving tools with depth-sensing nose-pieces and suitable speeds can help to avoid these problems.

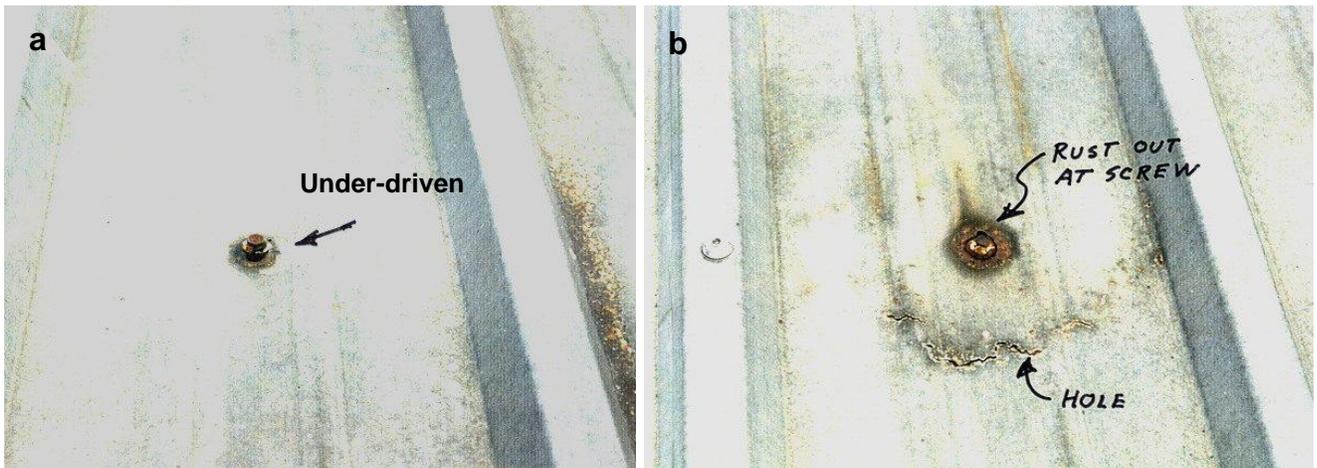
Figure 12. Photographs of under-driven fasteners with water leaking at fastener to cause corrosion at the fastener (a and b), and caused inside-out corrosion due to water saturation of the insulation (b).

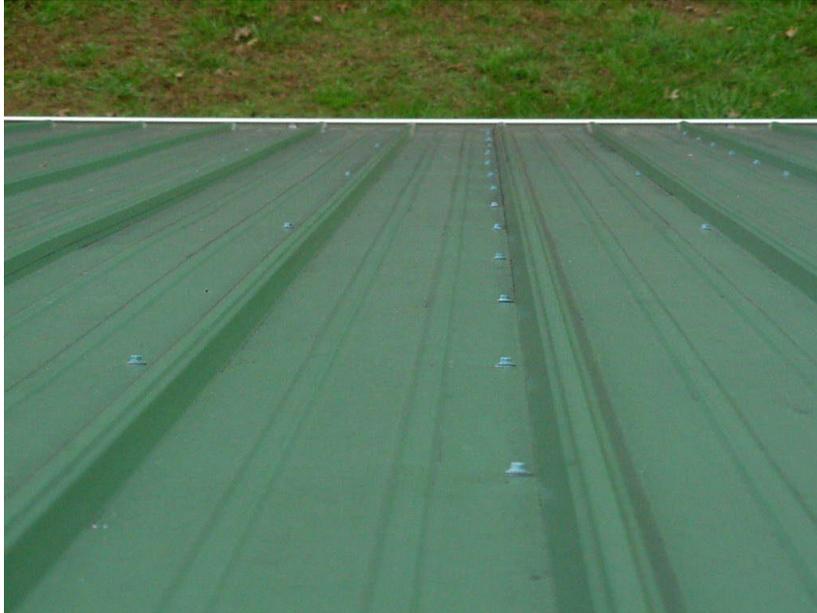
One of the distinctive features of a high slope metal roof is its unique appearance. The choice of the fasteners should match the color and the performance of the roofing panels. Otherwise, the appearance or even the performance of the roof may be adversely affected. Figure 13 shows a green colored prepainted galvanized steel roof with discoloration of the screws. Improper fasteners were used, which resulted in the red rusting of the screws and the discolored appearance of the roof. This problem would not have occurred, if the correct fasteners had been used (Figure 14).

Figure 13. Photograph of the prepainted galvanized steel roof with non-matching screws.

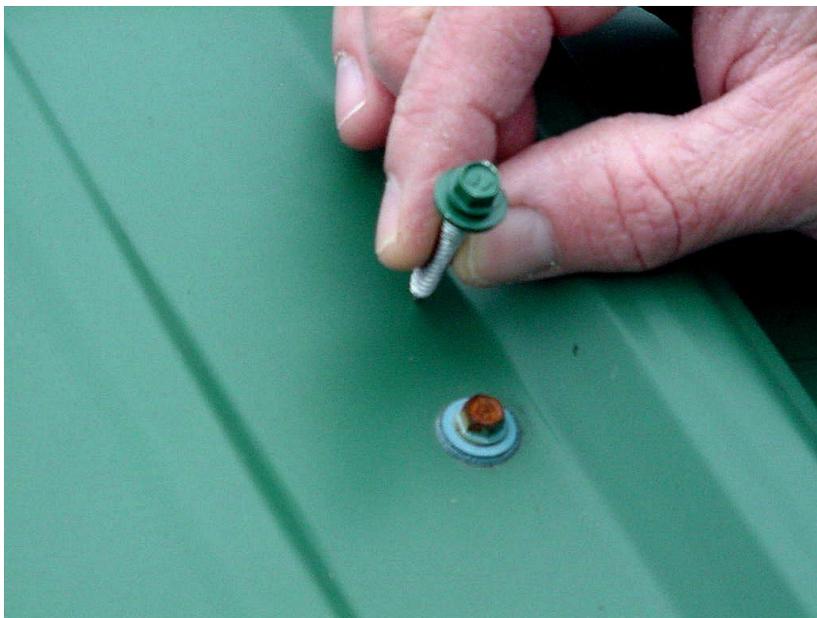
Figure 14. A close view of a non-matching screw with red rust and the correct screw, held in the hand, which should have been used for this application.

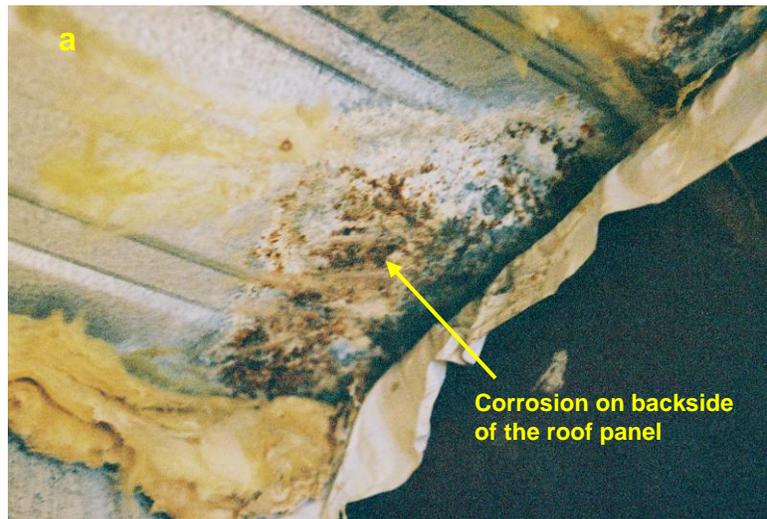
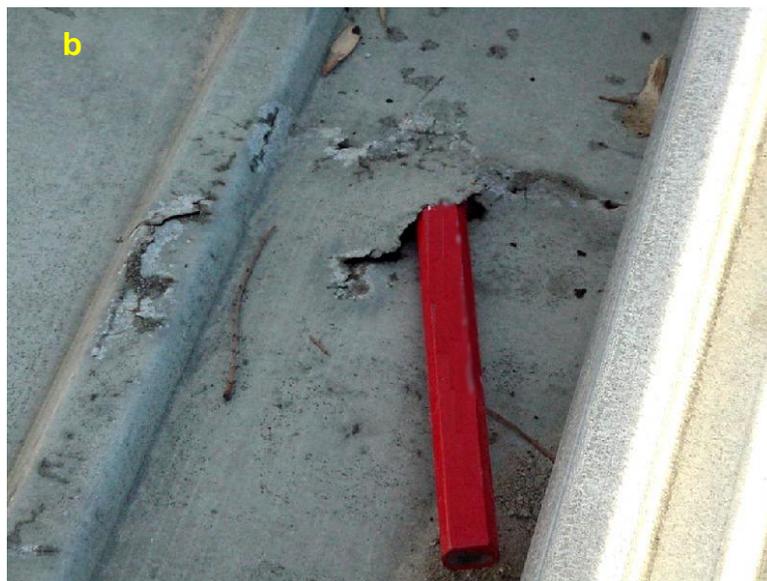
Insulation provides resistance to heat transfer and protects against condensation forming on cold surfaces inside the building or within the wall/roof system cavities. The insulation should have a vapor retarder face on the “warm” side of the insulation. For most buildings, the vapor retarder is on the inside surfaces facing the building interior. The thickness of the insulation must be designed to maintain the temperature of the vapor retarder above the interior dew point under the worst expected outside temperatures. All perimeter conditions and seams must be adequately sealed to avoid moisture penetration of the vapor barrier and provide a continuous membrane to resist the passage of water vapor. Failure to do so could cause wet insulation, which could cause corrosion on the underside of the roof panels (Figure 15a). This corrosion may lead to perforation corrosion from the inside of the roof panels (Figure 15b).

Figure 15. Photographs of roof panel corrosion due to wet insulation. The corrosion of the GALVALUME® panels was observed on the bottom side of the panels after the insulation was removed (a). Perforation corrosion was observed on the top side of the roof panels (b).

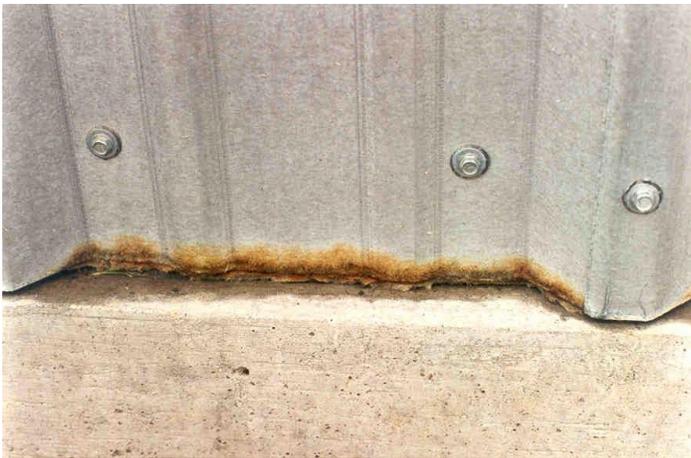
Figure 16 is a classic example of “insulation wicking” causing premature failure of the coated panel. The insulation soaked up the available moisture creating an environment that was always wet causing accelerated corrosion. The contractor should be fully aware that insulation and other building materials that can soak up moisture should not be exposed to the exterior of the building. One solution is to install the insulation at least one inch above the bottom edge of the panels and to fold the insulation face around the bottom edge of the fiberglass (see Figure 17).

Figure 16. Premature corrosion at the bottom edges of the GALVALUME® panel caused by insulation wicking.

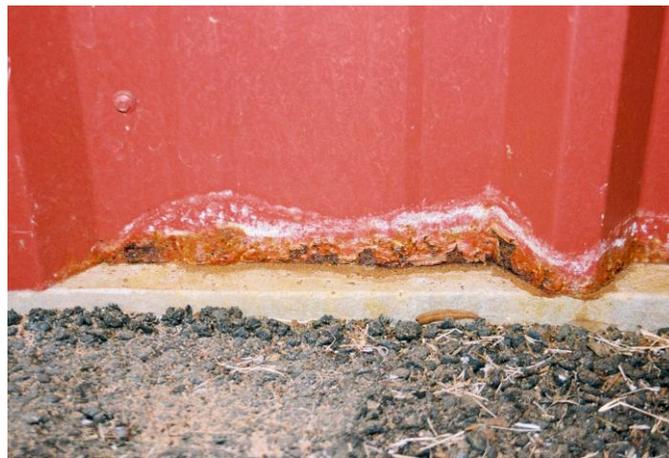
For bare and painted GALVALUME® products, direct contact with cement foundations is not recommended. Accelerated corrosion can occur due to the lime contained in the cement. An example of which with prepainted GALVALUME® siding is shown in Figure 18. Additionally, close proximity to a cement producing facility is not recommended as airborne cement is similarly corrosive to galvanized and GALVALUME® Coated Sheet Steels.

Figure 18. Premature corrosion at the bottom edges of the prepainted GALVALUME® panel caused by direct contact with the concrete foundation.

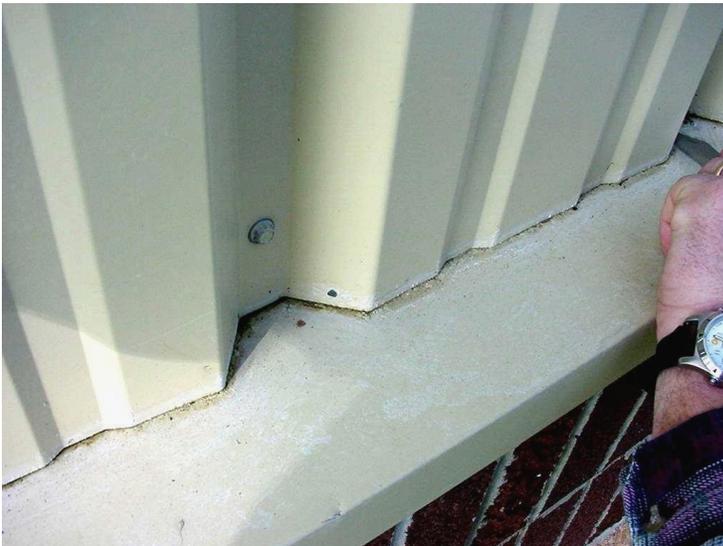
Figure 21 shows premature corrosion on the bottom edge of prepainted GALVALUME® siding where paint blisters and noticeable white residue stain could be observed along the panel edge and on the concrete surface, one year after the installation. This is a typical example of siding installed without flashing on a flat concrete base that does not allow water drainage.

Figure 21. Photograph of premature corrosion on the bottom edge of the siding.

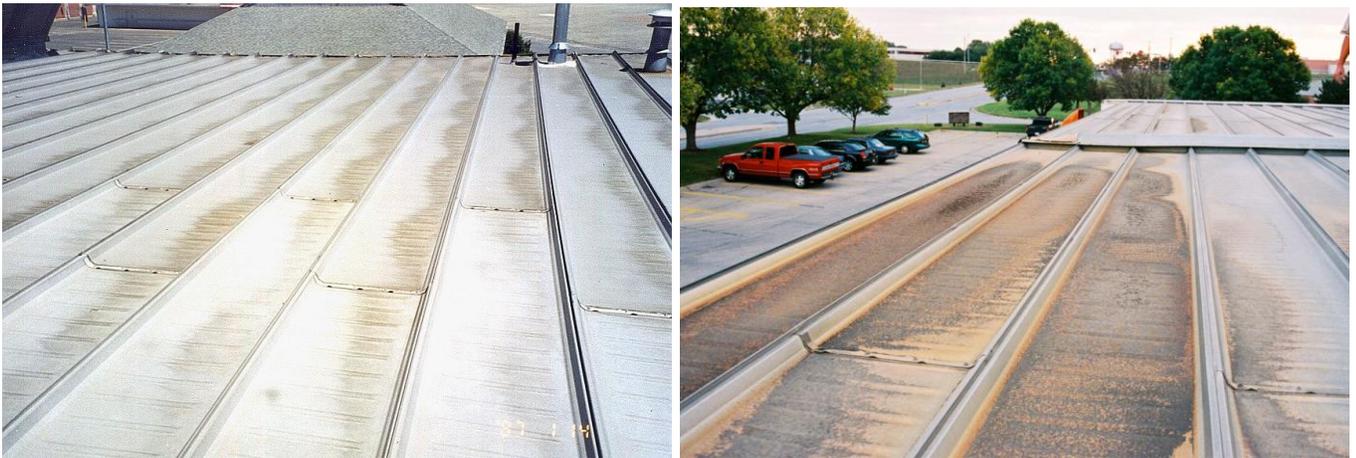
For low slope GALVALUME® roof applications, a minimum slope of 1/4:12 is recommended to provide positive water drainage maximizing the GALVALUME® roof performance. The examples in Figure 22 show standing seam roofs installed with slopes less than the 1/4:12 minimum, which resulted in water ponding in low areas causing corrosion of the metallic coating.

Figure 22. Photographs of water ponding on a GALVALUME® roofs due to improper slope of the roof.

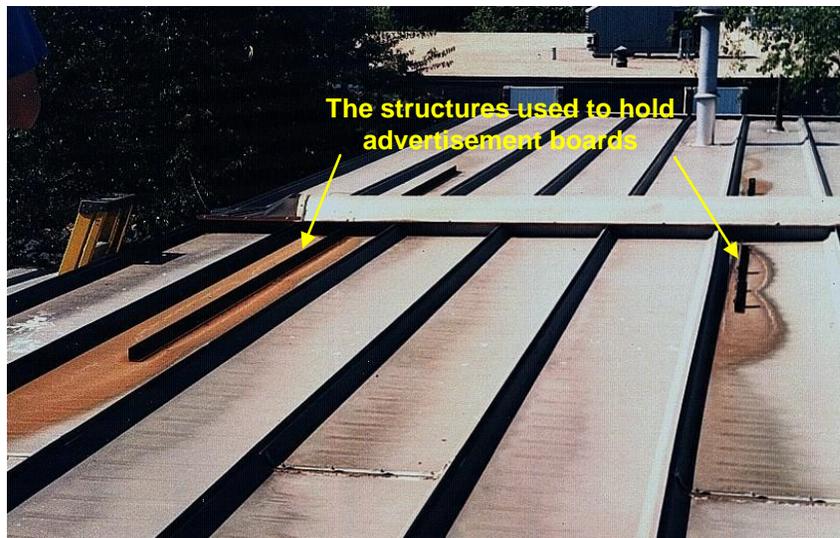
Water ponding may also occur in areas where localized deformation of the roof panels has occurred. The corrosion of the GALVALUME® roof panel in Figure 23 was caused by water ponding at the low spots caused by the weight of advertisement boards that had been positioned on top of the roof.

Figure 23. Photograph of a GALVALUME® roof after 21 years service. The localized corrosion was caused by water ponding at the low spots where the advertisement boards were set on top of the roof.

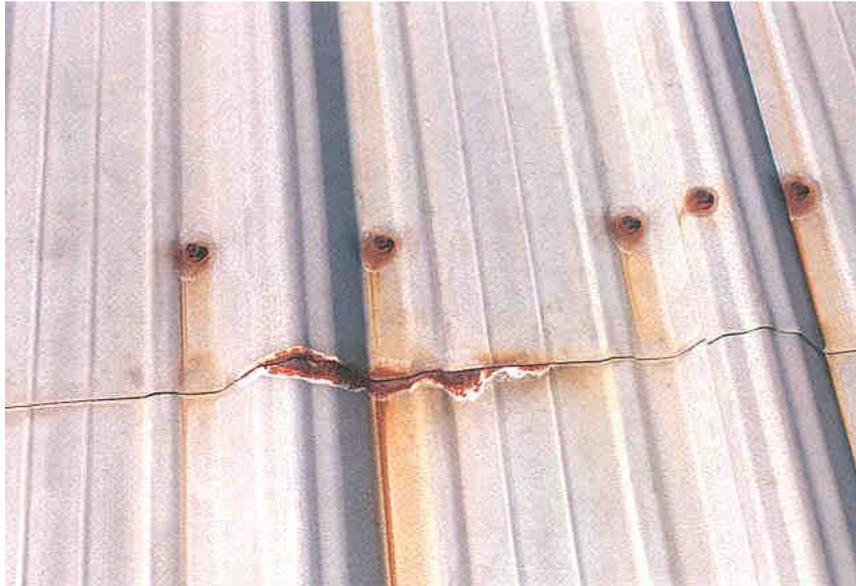
Sealant should be applied at panel end laps to prevent moisture from entering the panel lap joints and causing premature corrosion. Figure 24<sup>5</sup> shows the crevice corrosion caused by poor end lap sealing on a GALVALUME® roof. Figure 25 shows the paint blistering on a prepainted GALVALUME® roof caused by poor end lap sealing.

Figure 24. Crevice corrosion caused by poor end lap sealing on a GALVALUME® roof.

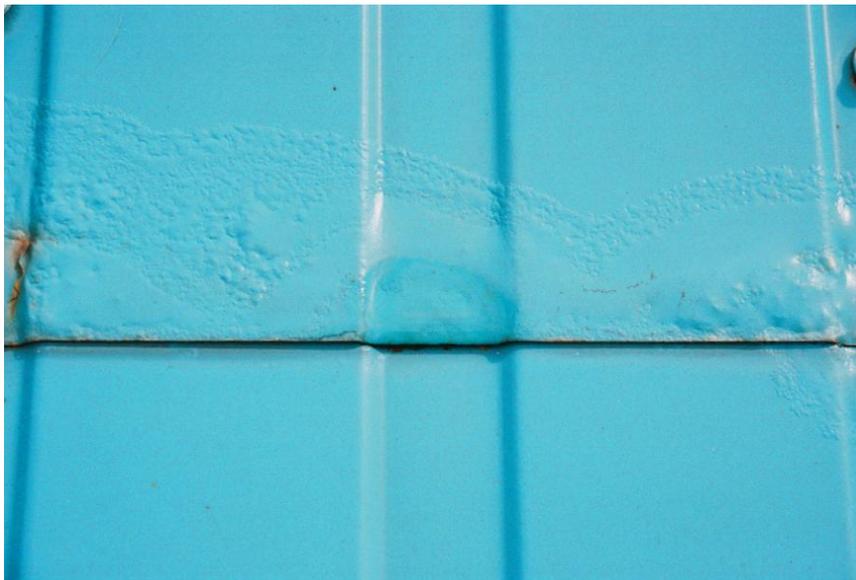
Figure 25. Paint blistering on a prepainted GALVALUME® roof caused by poor end lap sealing.

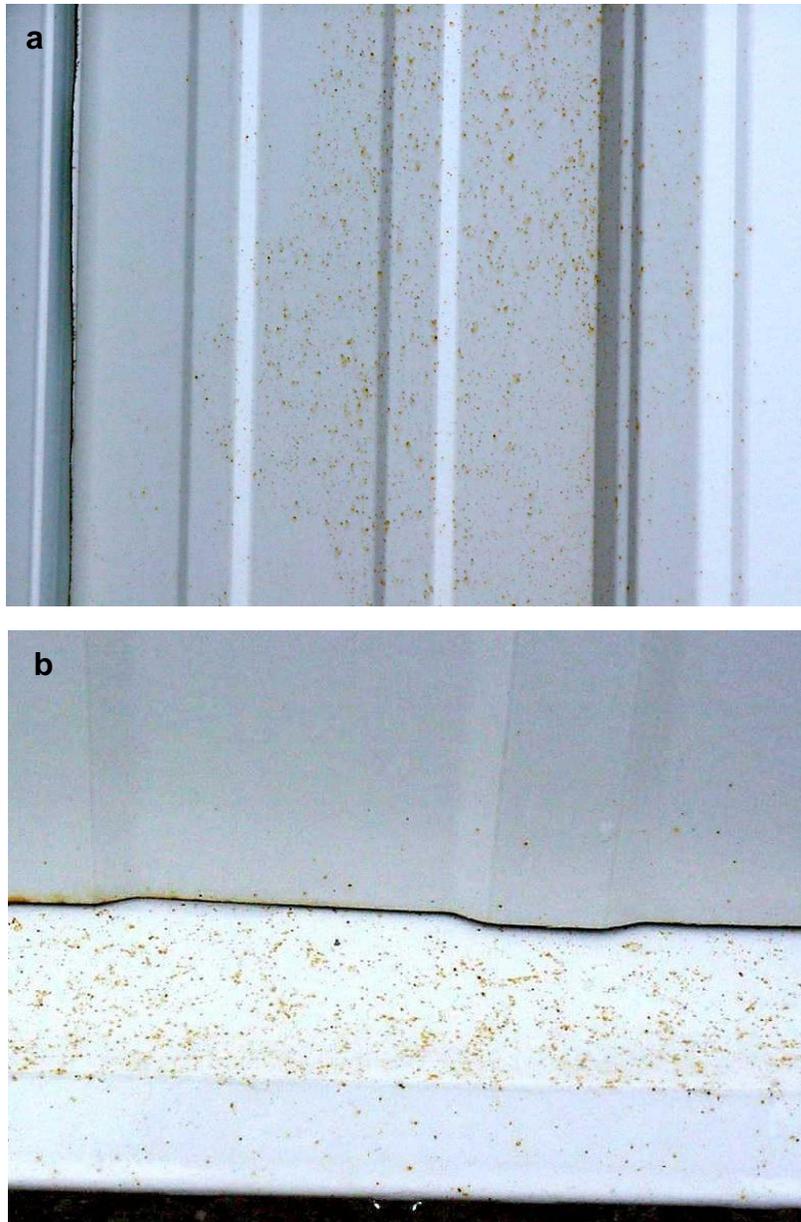
Metal debris from sawing, drilling and other construction processes should be removed during installation. Otherwise, the metal filings will red rust on the surfaces where they were deposited. Red rust of the metal filings may cause stain or discoloration on the surface of the panel whether it is bare or painted and cause appearance issues. Contractors should be cautioned about the importance of removing any debris generated during installation. Cutting and drilling should be done on the backside of the panels in order to avoid damaging the exposed surface with hot metallic particles. Figure 26 shows red rusted metal filings and the stains on a prepainted siding panel and on the concrete base at the bottom of the siding.

Figure 26. Photographs of red rusted metal filings and the stains on a prepainted siding panel (a) and on the concrete base at the bottom of the siding (b).

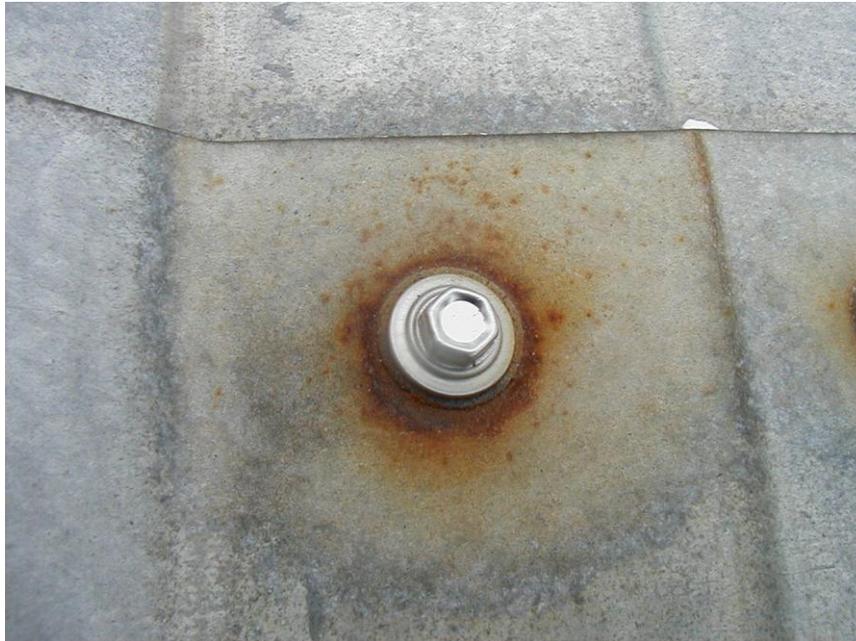
Figure 27 shows the red rusted metal filings on the surface of a bare GALVALUME® roof panel around a screw due to failure to remove the metal fines from drilling. Figure 28 shows another example of not removing metal filings after drilling screw holes on a prepainted GALVALUME® roof panel. Care must be taken to minimize the contact of hot metal filings from self-drilling or self-tapping screws with the coated panel surface. Any metal filings remaining on the panel surface must be removed at the end of each workday. Otherwise, those fine metal particles will corrode and result in rust staining on the panel surface.

Figure 27. Photograph of red rusted metal filings on the surface of bare GALVALUME® roof panel around a screw.

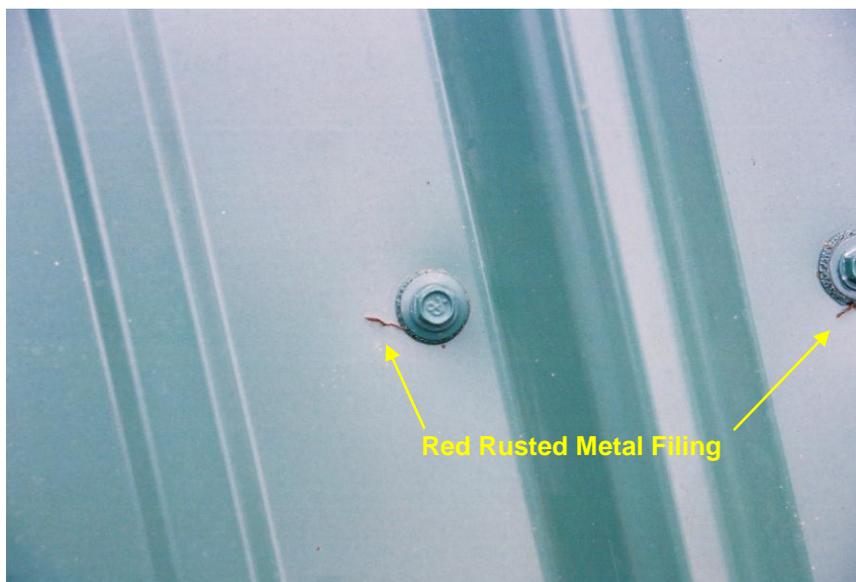
Figure 28. Photograph of red rusted metal filings from the screws on a prepainted GALVALUME® roof panel.

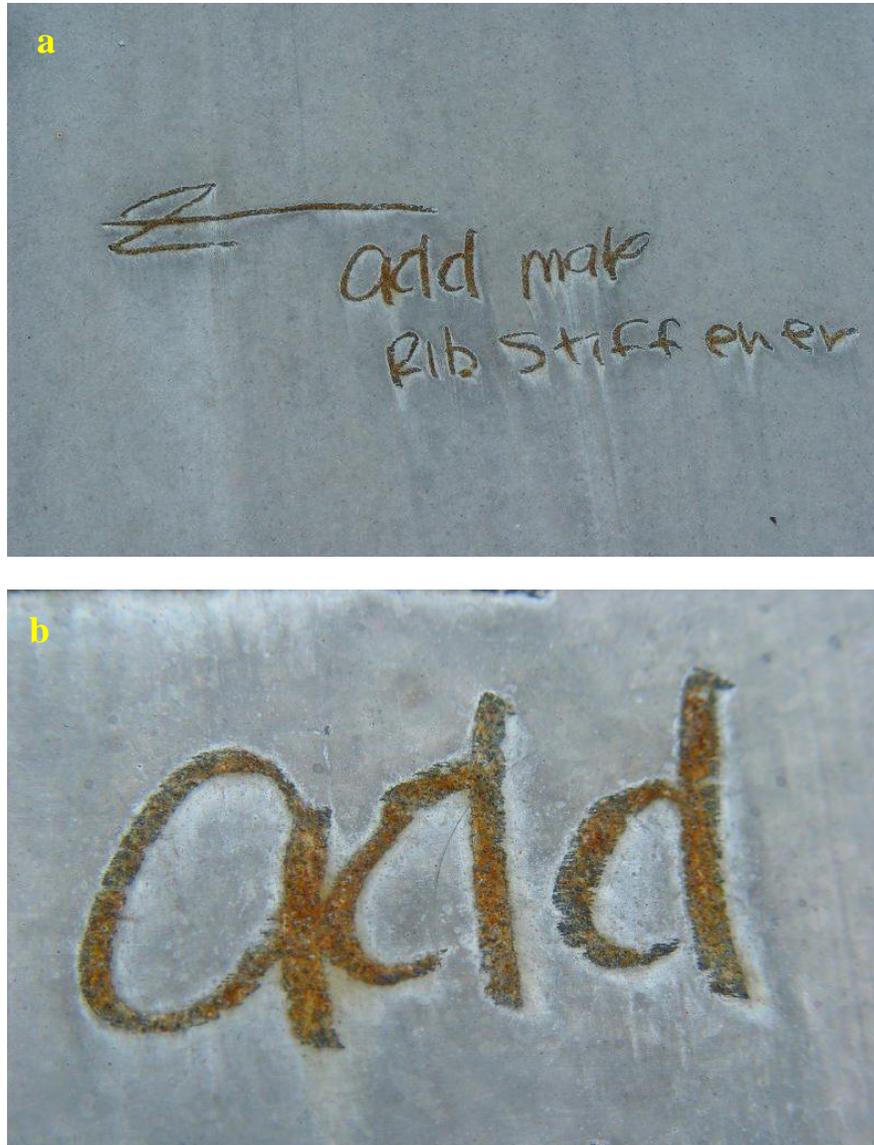
Pencil is made of graphite. When a pencil is used to write on galvanized steel it leaves graphite powder on the surface. Figure 29 is an example of pencil mark corrosion on galvanized steel sheet. Pencil mark corrosion is a form of galvanic corrosion. Because graphite is electrochemically very noble, 3 to 4 volts more noble than the zinc, a strong galvanic cell is created and the zinc on or adjacent to the pencil mark rapidly corrodes. The open circuit potential of graphite is cathodic to all metals and alloys in most aqueous environments. One should never write on galvanized steel with a pencil.

Figure 29. Photographs of pencil mark corrosion on galvanized steel sheet (a), and a magnified view of the mark (b).

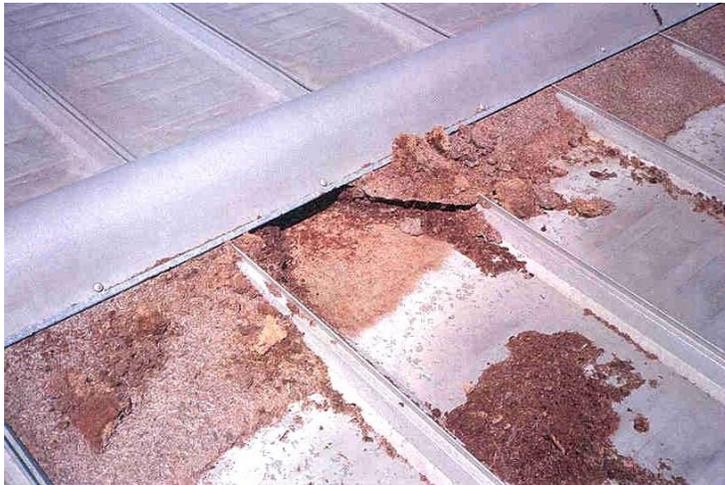
Figure 30. The wood chip debris piled near the ridge cap caused heavy corrosion of the roof panel due to water being retained by the debris.

Debris should be removed from the metal roof during or following installation and through regular roof maintenance because debris can cause staining and premature corrosion. Figure 30<sup>6</sup> shows wood chip debris piled near the ridge cap that caused heavy corrosion of roof panel due to water being retained by the debris. Figure 31<sup>6</sup> shows that the corrosion occurred under the treated lumber because chemicals, particularly copper compounds, leached from the wood accelerating the corrosion. Figure 32 is another example; a piece of metal tube left on the roof caused staining and corrosion of the roof panel.

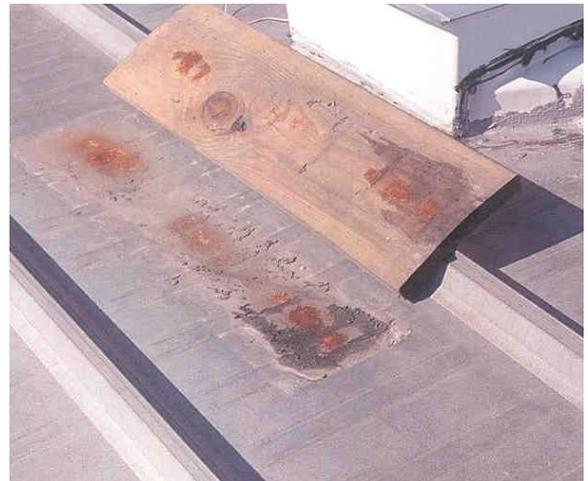
Figure 31. Corrosion occurred under the treated lumber because chemicals, particularly copper compounds, leached from the wood accelerating the corrosion.

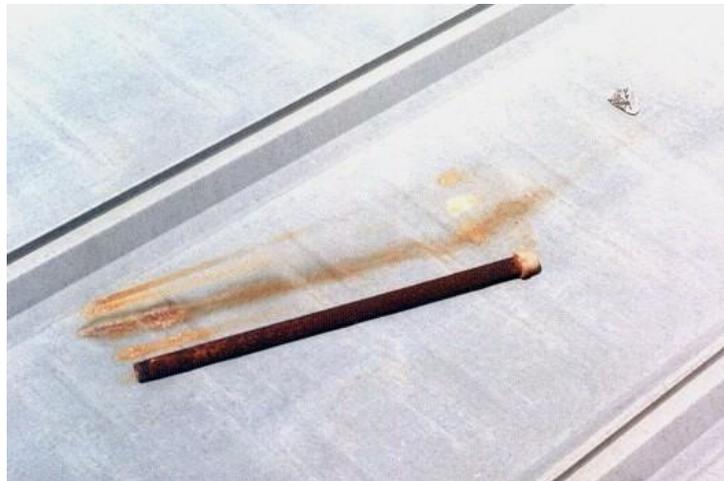
Figure 32. A piece of metal tube left on the roof caused staining and corrosion of the roof panel.

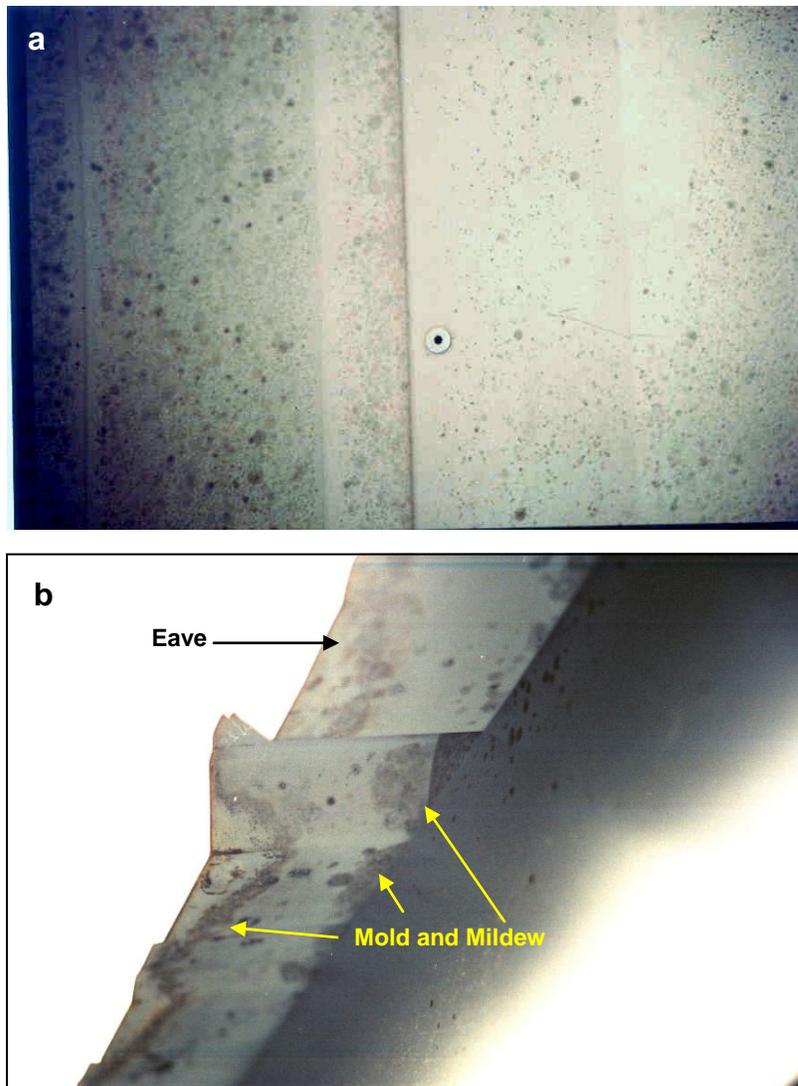
The photographs in Figure 33 show a green/brown appearance of mold or mildew on painted side wall panels and on the under side of the eave, which could cause staining on the surface. This is considered a maintenance issue. Proper ventilation and periodic cleaning should reduce the impact of mold and mildew. Remove mildew by wiping or by using a power spray. Then wash the area with an antiseptic cleaner such as bleach. Rinse the area thoroughly.

Figure 33. Mold or mildew buildup on painted side wall panel (a) and on the under side of the eave (b) where the building was surrounded by a woody area and constantly exposed to a high humidity environment.

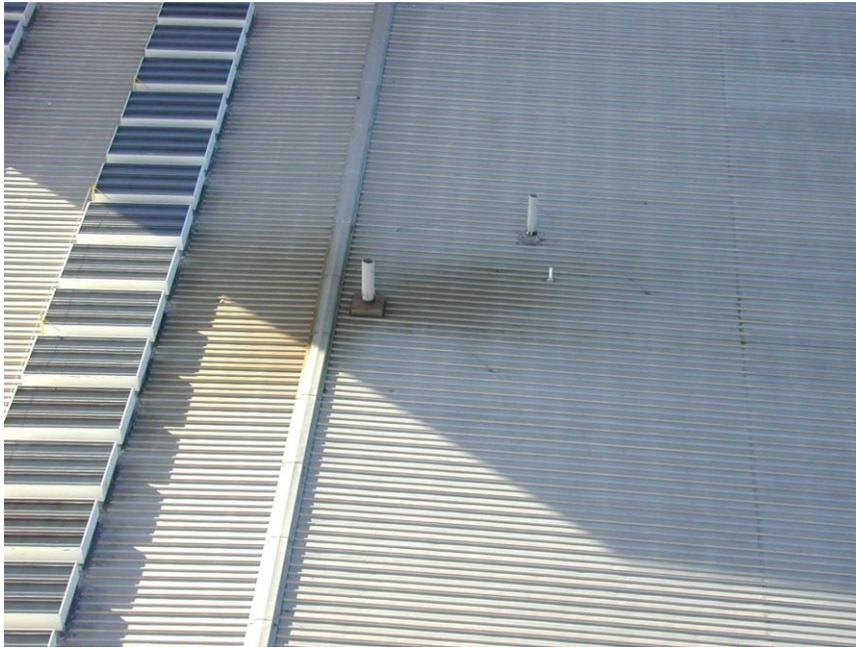
Exhausts discharged through roof stacks can sometimes create corrosive environments around them. The roof panels should be inspected periodically. The panels around exhausts can be coated with recommended maintenance paints, if it is necessary. Figure 34 shows a bare GALVALUME® roof corroded around the vent from a laboratory where acid was constantly used. Figure 35<sup>7</sup> shows that the GALVALUME® roof around the roof stacks was corroded after 20 years due to the exhaust from a space heater.

Figure 34. The bare GALVALUME® roof was corroded around the laboratory vent.

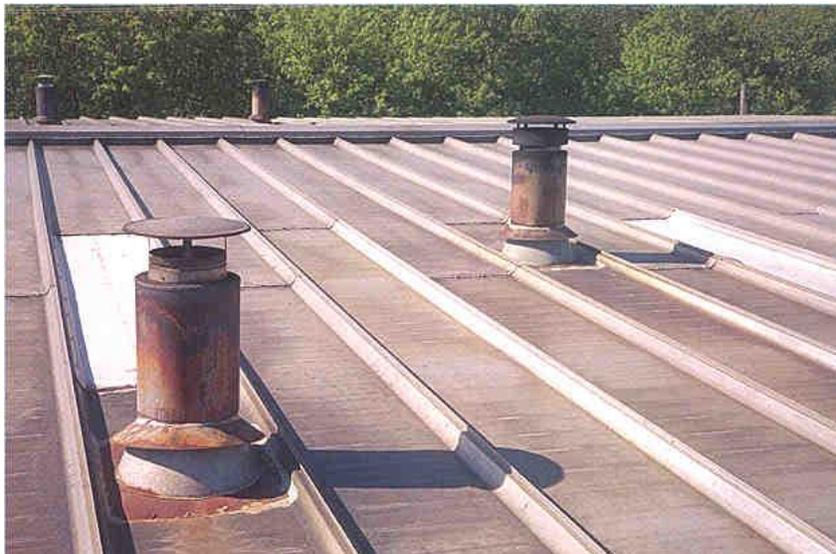
Figure 35. The GALVALUME® roof was corroded around the roof stacks.
