United States Steel Corporation

# Resolution Manual For Metal Building Construction

## Job Site Imperfections

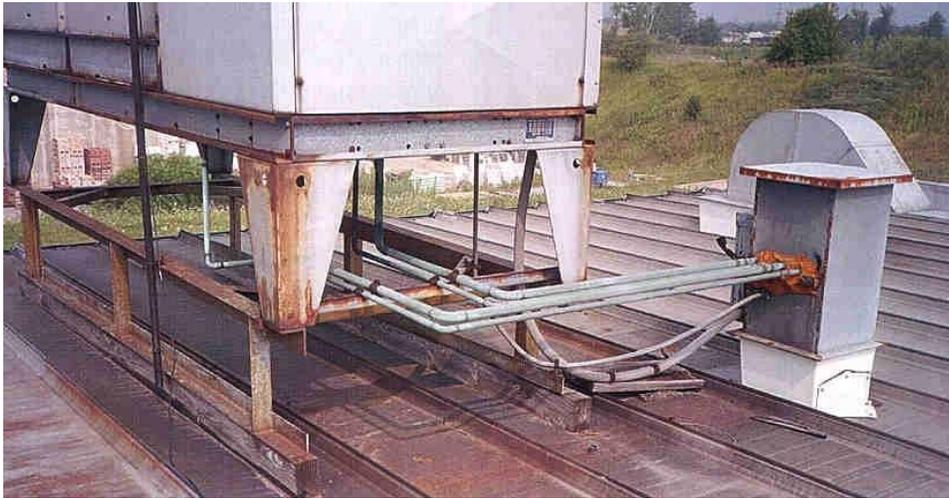
Galvanized and GALVALUME<sup>®</sup> panels should not be in contact with, or subject to, water runoff from copper, lead, or uncoated steel materials. Condensation water from air conditioning units typically contains dissolved copper, which should be discharged through a plastic pipe extended beyond the edge of the roof. The effect of the condensation water runoff from the copper piping on the GALVALUME<sup>®</sup> panels is significant in both outdoor and indoor situations, such as shown in Figure 36<sup>8</sup> and in Figure 37.

Figure 36. GALVALUME<sup>®</sup> roof panel corrosion due to condensation water runoff from the copper pipes.

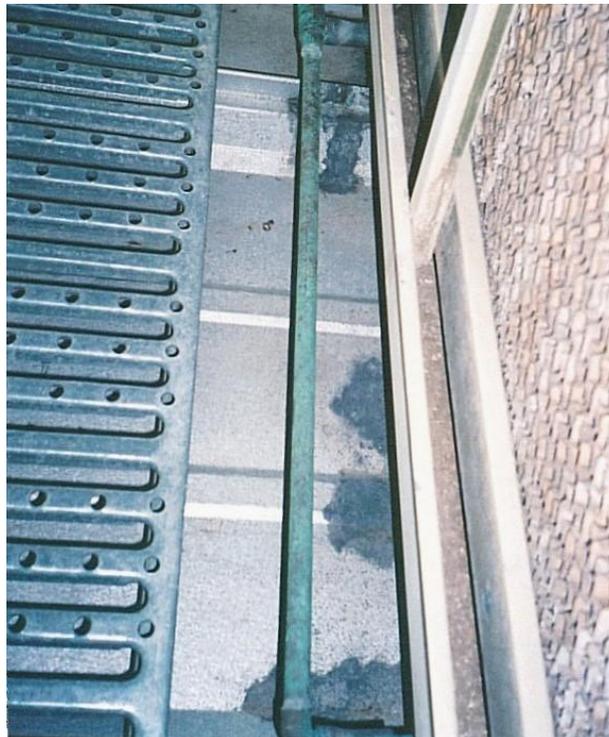
Figure 37. GALVALUME<sup>®</sup> panel corrosion due to condensation water runoff from the copper pipes.

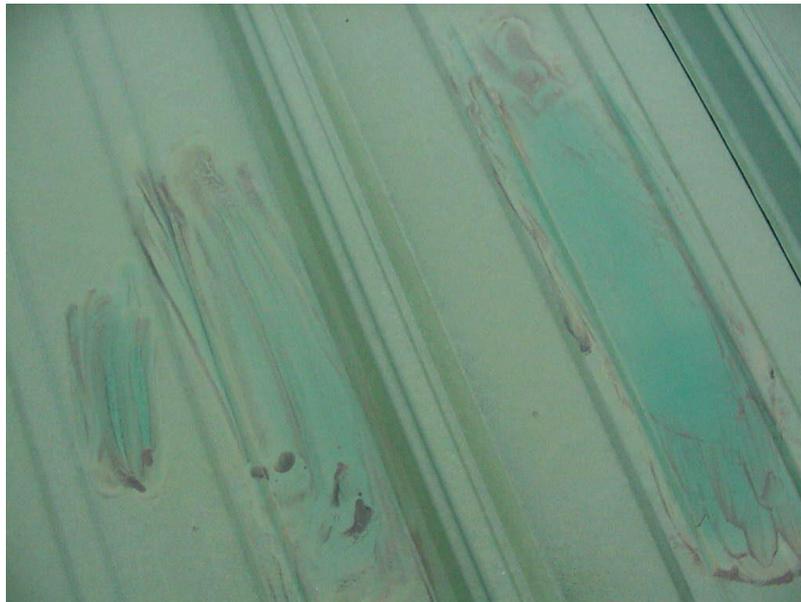
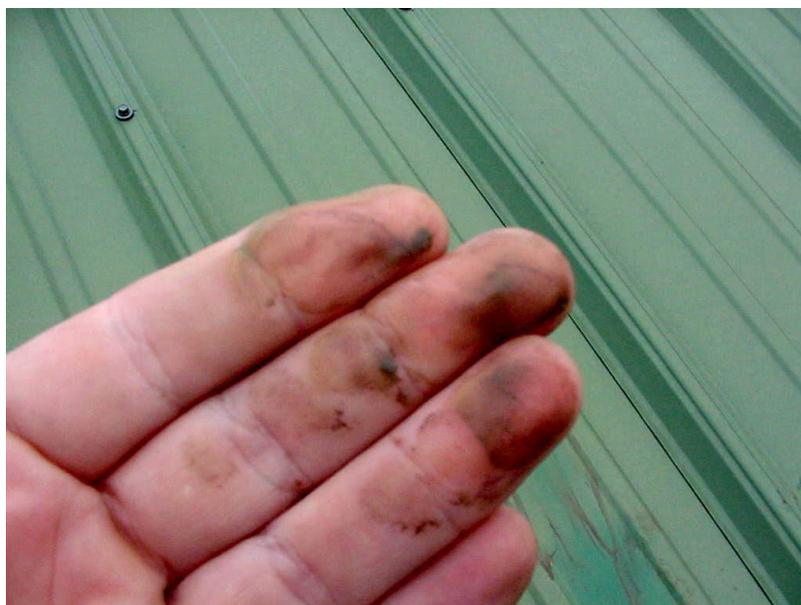
Two types of dirt accumulate on buildings: dry soil and greasy or organic residues. The dry dirt, by itself, washes off with rain or high-pressure water spray. Greasy residues do not wash off in rain and hold dry soil and chalk tightly to the surface. These residues originate from automobile exhaust, fireplaces, ventilation fan oil, pesticides, and various other common sources. This is the kind of dirt that requires cleaners for removal. Detergents, ammoniated cleaners and solvents are particularly effective in removing this greasy kind of dirt. Generally, lighter colors show dirt more than dark colors. However, dirt remaining on a darker roof can also cause discoloration, an example of which is shown in Figure 38. The bright color has been covered by dirt.

Figure 38. The prepainted GALVALUME<sup>®</sup> roof panel discoloration is due to dirt coverage.

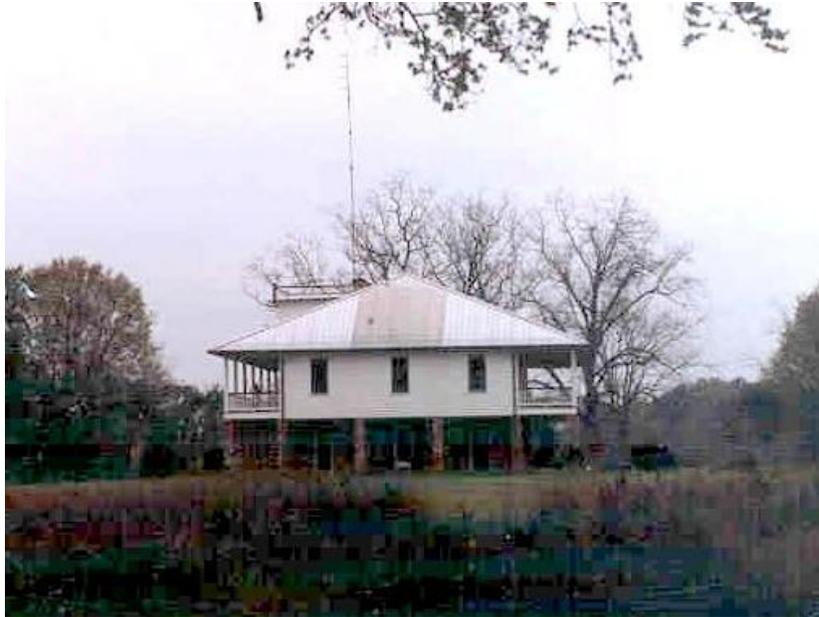
Bare GALVALUME® Coated Sheet Steel is not recommended for high visibility applications, such as the high slope roofing application shown in Figure 39, because of the potential for differential darkening. The darkening variation can be minimized by supplying material from one supplier and from one master coil. Consecutive master coils supplied by the steel mill will also reduce, but not eliminate the possibility of variation. The darkening variation may also be observed on ACRYLUME® Coated Sheet Steel panels (Figure 40). Therefore, if the application requires a consistent surface appearance, a painted product is recommended.

Figure 39. Differential darkening of bare GALVALUME® panels on a high slope roofing application.

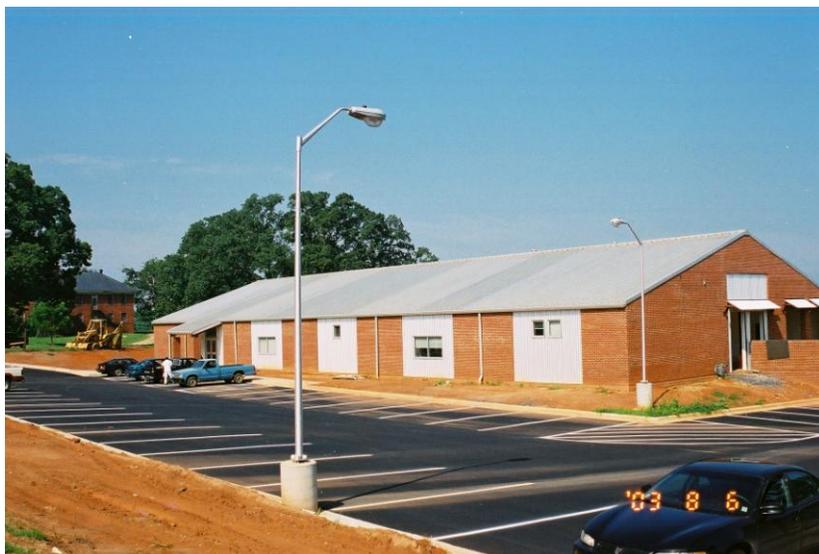
Figure 40. Differential darkening of ACRYLUME® panels on a high-slope roofing application.

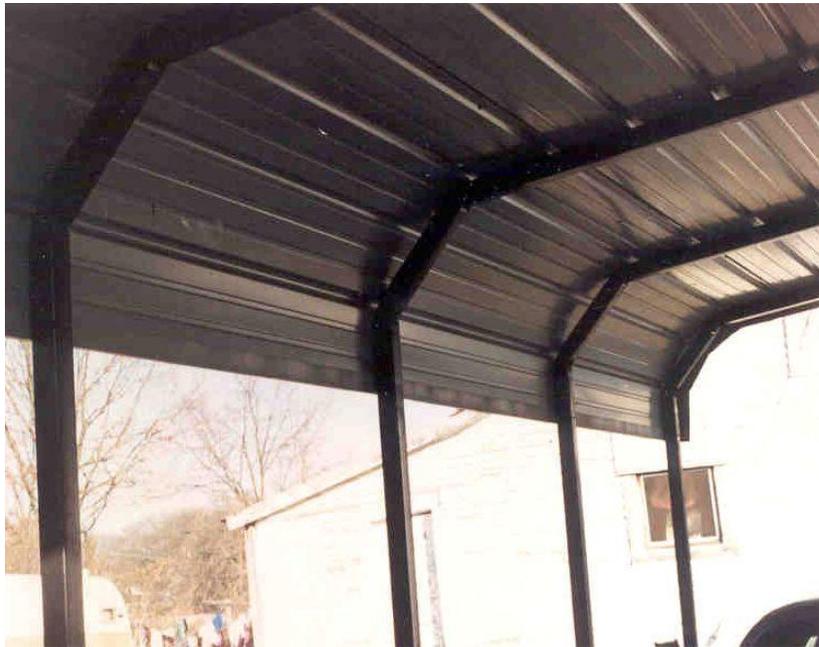
The design of metal roofing should allow water runoff and also provide adequate ventilation to prevent condensation. An improper design will affect the corrosion performance of the roofing panels whether they are bare or painted. The roof design shown in Figure 41 does not allow rainwater to runoff along the curvature of the roof, causing condensation to accumulate on the backside of the panel along the ribs (Figure 42). Contractors should be warned of the potential impact of such applications and designs, which do not allow effective water runoff or proper ventilation.

Figure 41. Improper roof profile design of a pole building with open sides does not allow rainwater to runoff along the curvature of the roof.

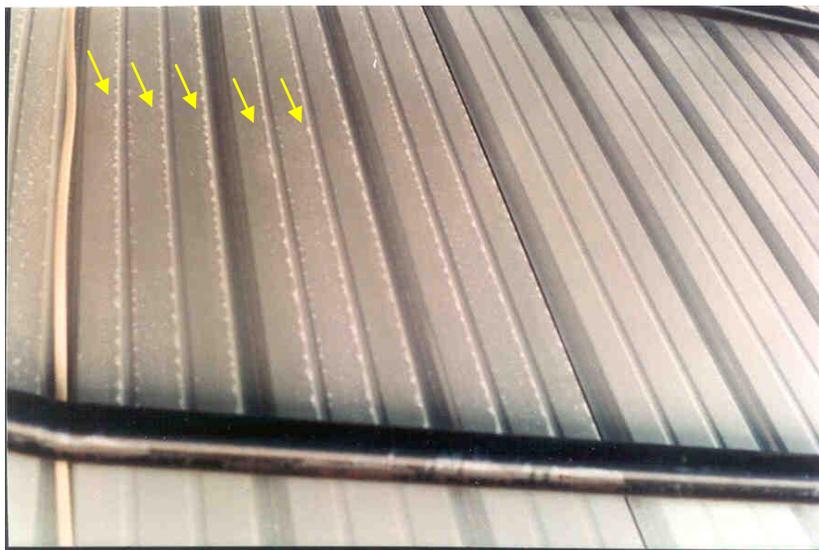
Figure 42. Photograph of the backside of the roofing panel shows condensation accumulating along the ribs of the panel as the arrows indicate.

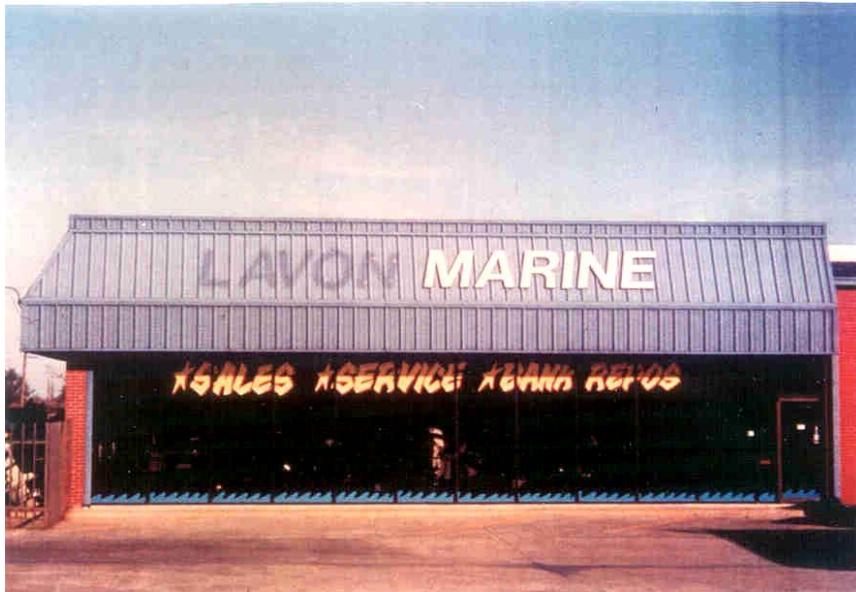
Fading is typically caused by the breakdown of the components of the paint film by UV light from the sun. Paint suppliers indicate the degree of fading that can normally be expected from a particular paint system over a given time period. An area that is blocked from the UV exposure will have less fading than areas exposed to the sun. An example of this is shown on the building in Figure 43. In the case of non-uniform fading of the paint, such as the prepainted roof in Figure 44, there are noticeable differences in color between one section and another section of the roof panels. The amount of fade should be evaluated by the representatives of the coil coater or paint supplier to determine the cause.

Figure 43. Color fading of the paint on prepainted panels due to UV light from the sun.

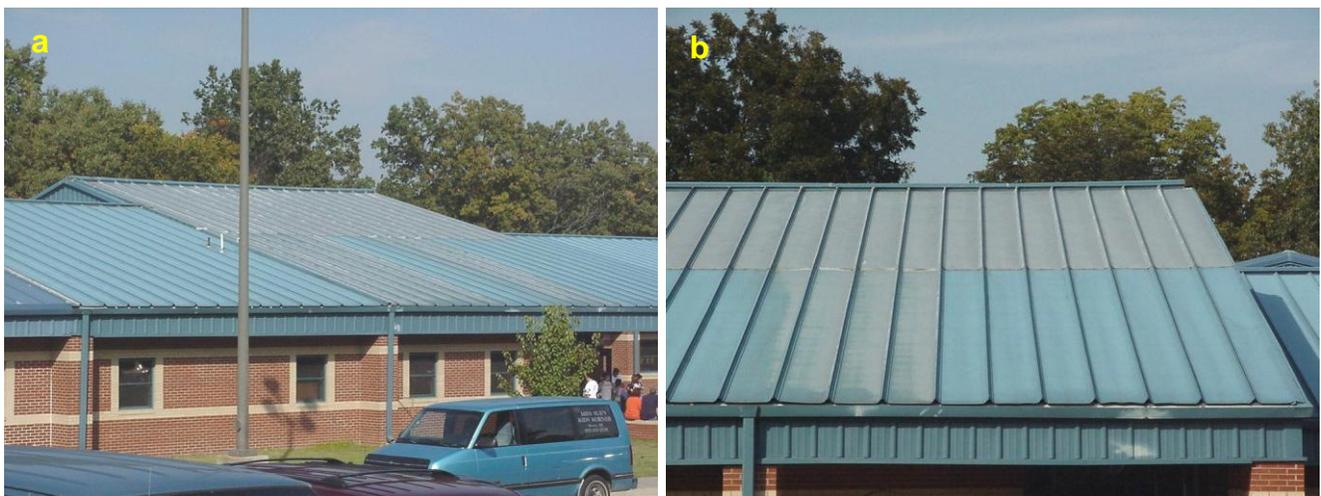
Figure 44. Non-uniform fading of a prepainted roof with noticeable differences in color from one section to another section (a) and its close look (b).

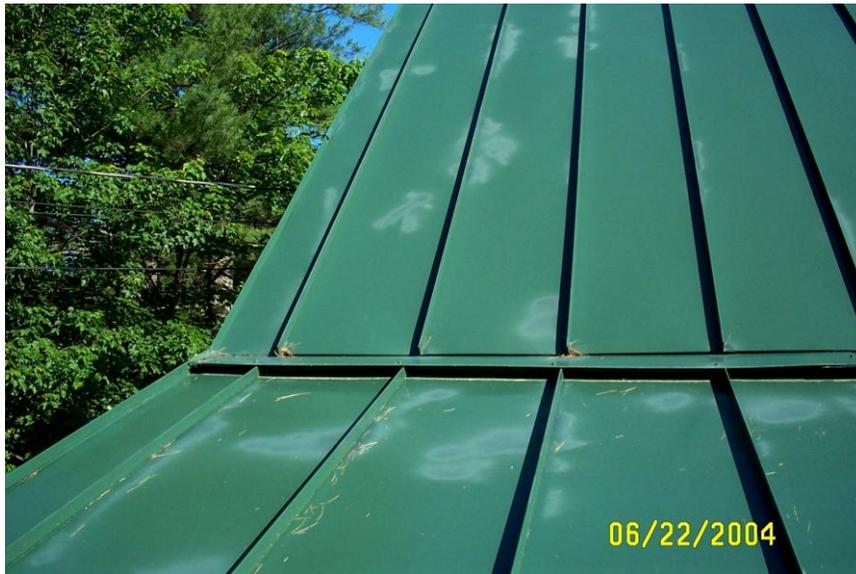
Touch-up paint is often used to repair or cover the scratches, abrasion marks or other lightly damaged areas on prepainted building panels. Appropriate touch-up paints, normally supplied by the paint manufacturers, will match the colors and meet the performance requirements with the paint on the building panels. If unsuitable touch-up paint is used, it may cause differential chalking and fading appearance on the painted panel, which may require repainting of the entire affected surface. The pictures below demonstrate the poor performance of improper touch-up repair paints, which have caused differential chalking and fading appearance on the prepainted GALVALUME® steel roof (Figure 45) and on the prepainted hot-dip galvanized steel siding (Figure 46).

Figure 45. Differential chalking and fading appearance on the prepainted GALVALUME® steel roof with improper touch-up paint.

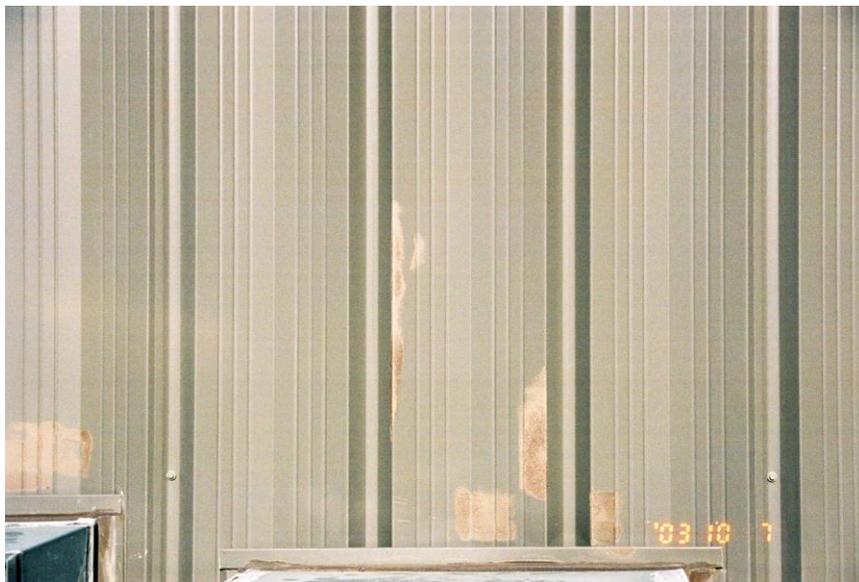
Figure 46. Differential chalking and fading appearance on prepainted hot-dip galvanized steel siding with improper touch-up paint.

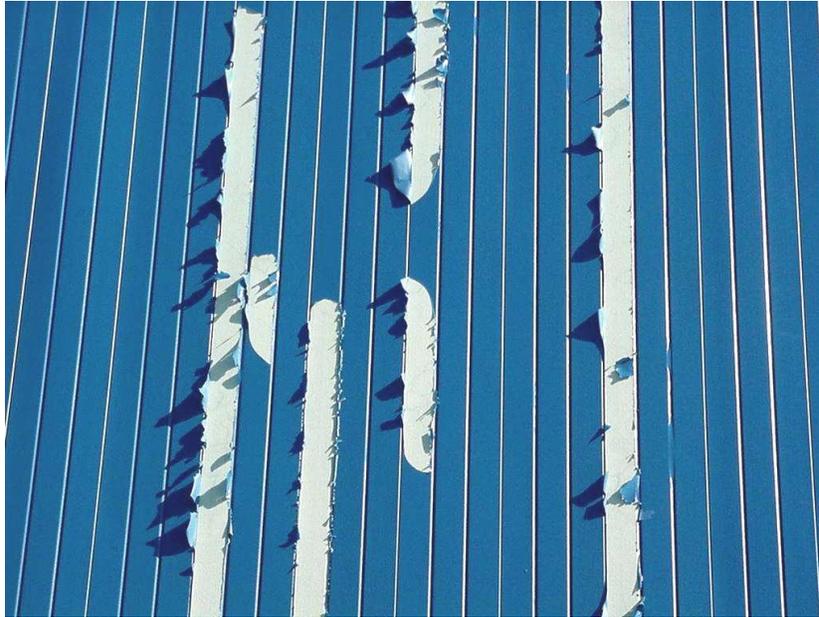
Generally, paint systems for exterior building panel applications consist of a primer and a topcoat. The primer should provide good adhesion to the coated steel substrate and to the topcoat. Figures 47 to 49 show an example of inter-coat adhesion failure of the paint where the topcoat has delaminated from the primer on the prepainted GALVALUME® Coated Sheet Steel. The primer still remains on the surface of the coated steel sheet substrate (Figure 49). In this case, the failure is not related to the GALVALUME® Coated Sheet Steel. The coil coater and paint supplier should be contacted to resolve this issue.

Figure 47. Inter-coat adhesion failure on a prepainted GALVALUME® panel.

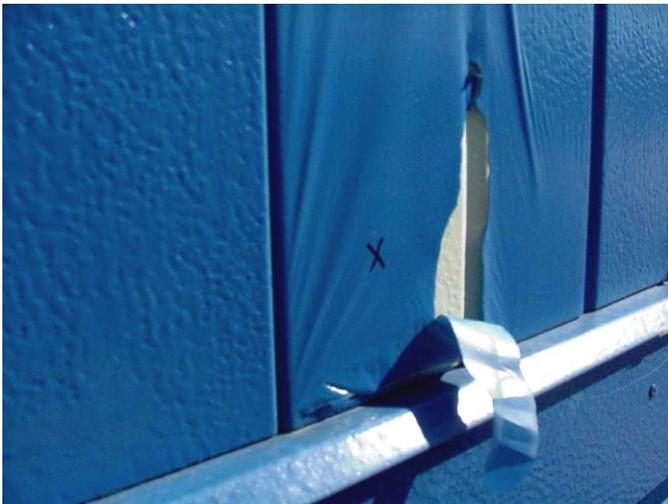
Figure 48. The topcoat delaminated from the primer.

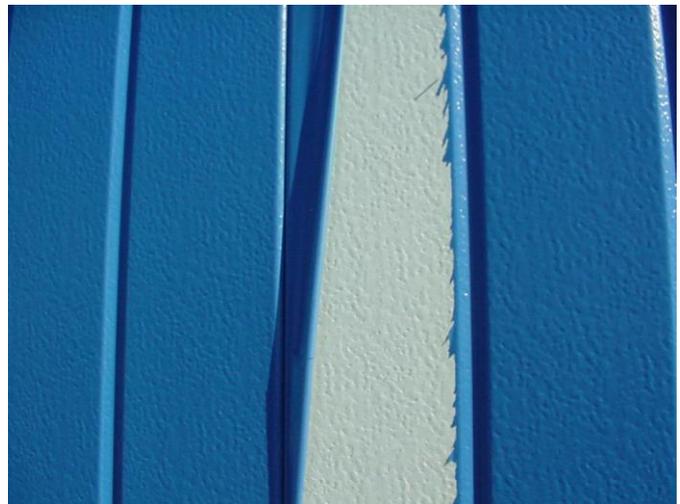
Figure 49. The primer remained on the panel where the topcoat peeled off.
