United States Steel Corporation

# Resolution Manual For Metal Building Construction

## Job Site Imperfections

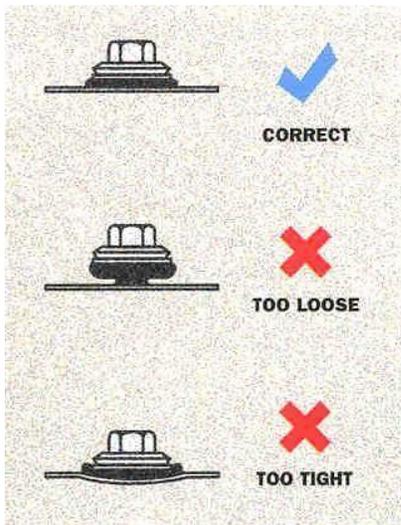
Figure 10. Schematic example of the proper and improper installation of fasteners.

Fasteners should be installed properly to avoid being over-driven, under-driven or driven at an angle. Figure 10<sup>3</sup> is a schematic example of the proper and improper installation of fasteners. Properly seated and installed fasteners should be watertight and not allow water to leak or allow water to collect around them. Over-driven fasteners may cause depressions around the fasteners, which can collect water and accelerate corrosion. Therefore, impact-type tools should not be used. Figure 11 is an example of over-driven fasteners. The GALVALUME® material around the fasteners was corroded due to water ponding in the depression. The corroded area around the fastener increased with increasing the depth of the depression. Under-driven fasteners or fasteners that “back out” over time can allow water to leak at fasteners allowing water to saturate insulation causing inside-out corrosion (Figure 12<sup>4</sup>). Driving tools with depth-sensing nose-pieces and suitable speeds can help to avoid these problems.
